# Manhole Inspection Summary

Manhole # S33AA\_007MH

**Location** Address: **900 CHARLES ST**

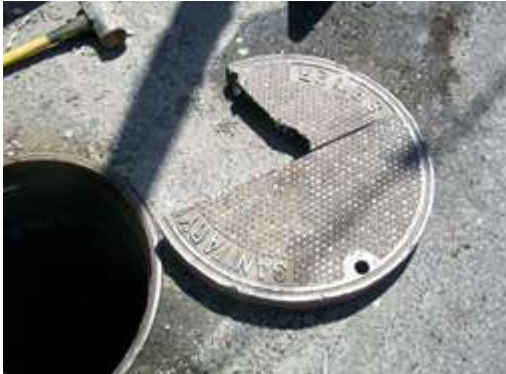
CUT OPEN

CUT OPEN LID AND REPLACED WITH  
NEW 24" SANITARY BY REI/DRAYCO

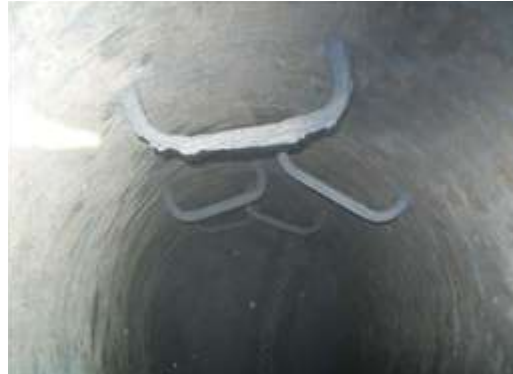
Defect 2

**Steps** Count: **7** Missing: **0** ☒ **Corroded**

CORRODED STEPS

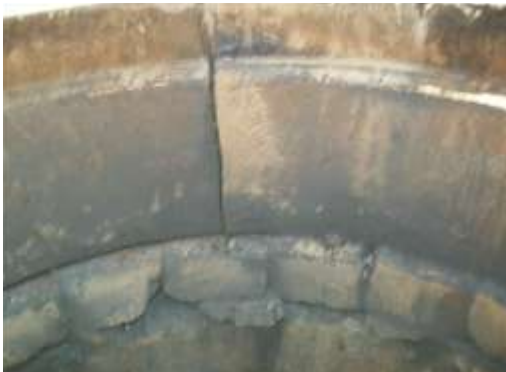
Defect 1

**Frame** Offset: **0** (in.) Condition: ☐ Sound ☒ **Cracked** ☐ Leaks

CRACKED FRAME

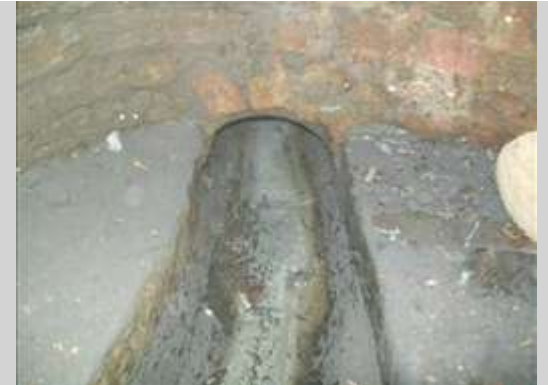
12 O'Clock Outflow

8 in. Circular Gravity Sewer  
Pipe Out @ 12 O'Clock

Invert Depth: **11.58** (ft.) Flow Characteristics: **Slow**

Infiltration: **None** Pipe Seal Cond: **Sound**

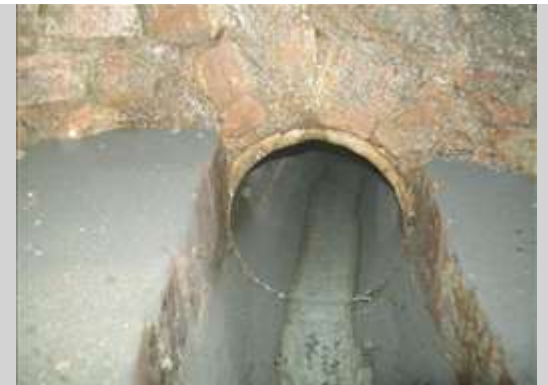
8 O'Clock Inflow

8 in. Circular Gravity Sewer  
Pipe In @ 8 O'Clock

Invert Depth: **10.83** (ft.) Flow Characteristics: **Slow**

Infiltration: **None** Pipe Seal Cond: **Sound**
